MILL POND DAM

NH 00387

PRELIMINARY INSPECTION REPORT
NATIONAL DAM INSPECTION PROGRAM

DECEMBER 1980

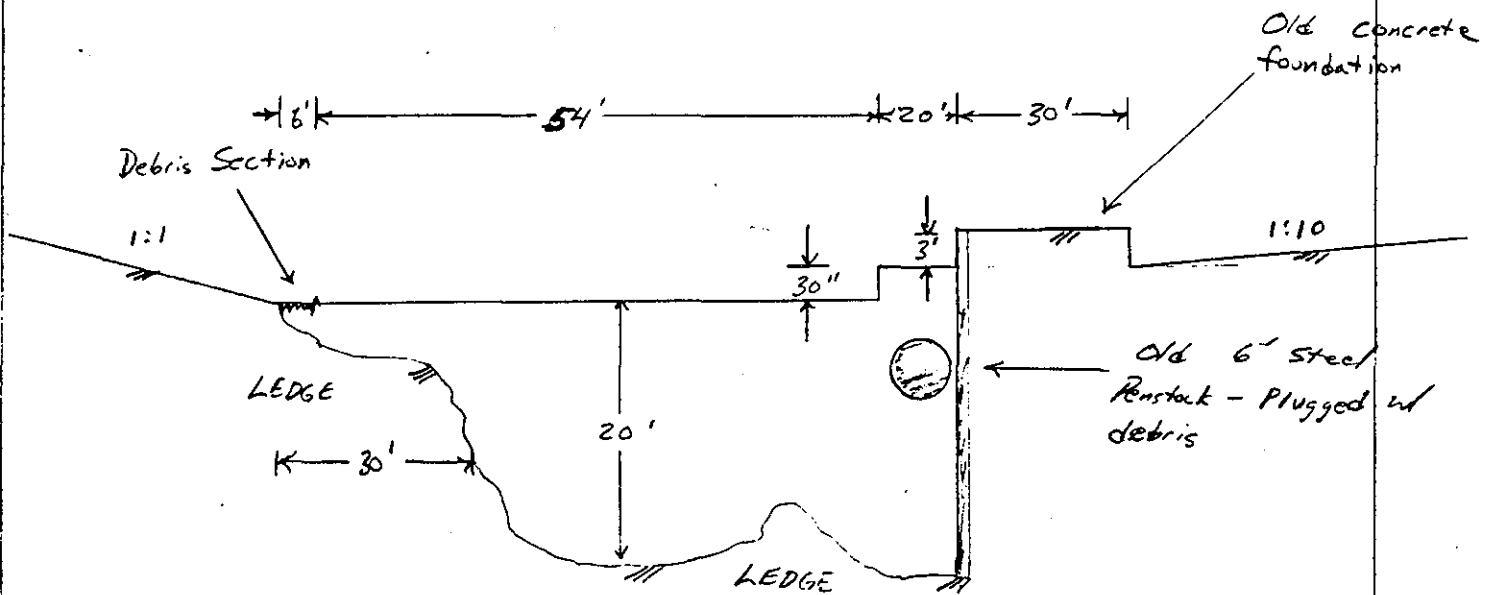
Schematic of Mill Pond Dam

The dam consists of a gravity, overflow type spillway constructed of concrete and founded on bedrock. The spillway is generally in fair condition except for a 6 foot section of the right side that has deteriorated and accumulated low flow debris. There is an abandoned penstock at the left abutment which has been plugged but is leaking at the present time. The dam is approximately 80 feet long and 24.1 feet high with a spillway crest length of approximately 60 feet. The spillway crest elevation is approximately 160 feet (NGVD) with approximately 2.1 feet of freeboard. The right abutment is bedrock and serves as a training wall downstream. The remains of a burned sawmill structure are located at the left abutment. There are no operable outlets at this dam and no means of lowering the reservoir in an emergency. A detailed inspection was not made.

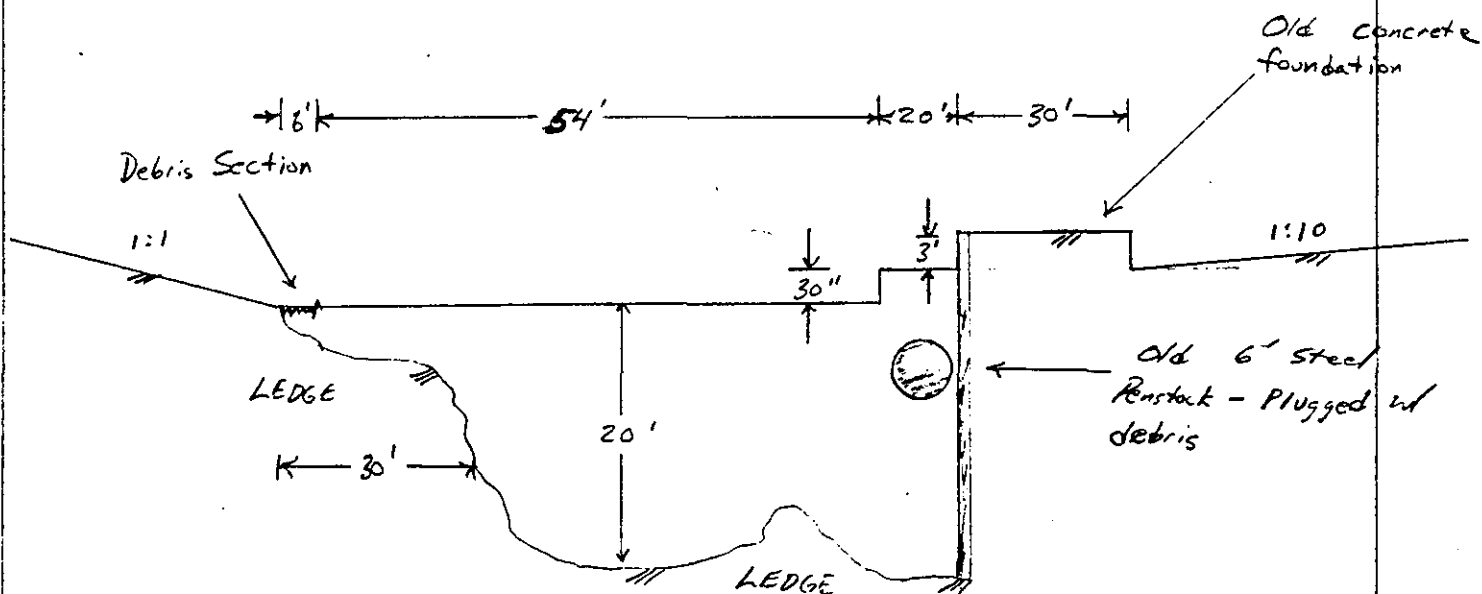
Schematic of Mill Pond Dam
(not to scale)

Assume that the dam fails at the level of the right abutment, which is

Also assume that the leak through the plugged penstock would contribute only a negligible amount of flow during flood stages.

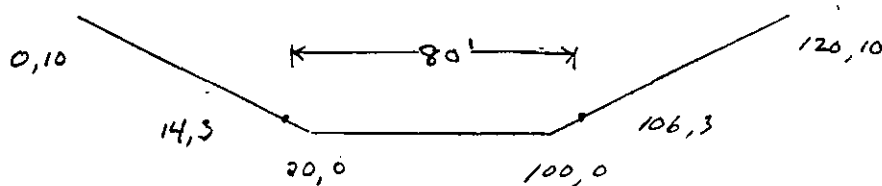
Sketched below is a typical downstream cross section. The rating table for this section is found on the next page.

From the stream rating table, a Normal Outflow at Failure of 790 cfs would create a stage of 1.8' feet above the channel bottom. At failure, a flow of 6270 cfs would cause a 6.2' stage.
